Spinal Cord Stimulator Paddle Lead Breakage as an Indication for Reoperation Scott H Boop B.S.; Angela Wilcox Palmer MD; Erika A. Petersen MD University of Arkansas for Medical Sciences

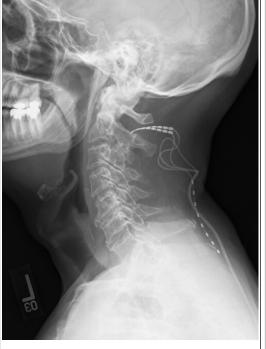
# Case 1

62 year-old male who had undergone high cervical SCS paddle lead placement sustained a motor vehicle collision. Imaging revealed migration of the paddle lead. The patient described worsening neck and arm pain, and revision was therefore performed. The paddle electrode had separated from the lead body at the junction. It appeared that traction on the lead had drawn it through the anchor, delaminating the paddle.

Migration of Spinal Cord Stimulator Paddle Lead

Paddle Lead Delamination Noted Intraoperatively

Given that lead-anchor-fascia disruption is a possible failure mechanism for SCS, improvements in product design and surgical technique are necessary to avoid similar failures. Wireless technology, new "stretchy" lead materials, strategic placement of strain relief loops, and better leadanchor design represent means by which this type of failure might be mitigated.

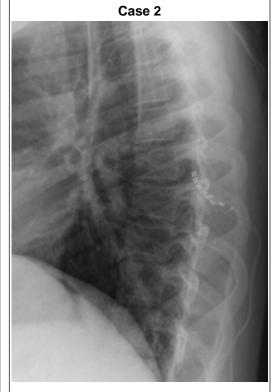
40 year-old male reported loss of stimulation efficacy six months after thoracic SCS implantation. Plain films revealed the lead partially withdrawn from the epidural space, but programming adjustments regained effective coverage. Two months later, when efficacy was again lost, further out-migration of the lead with separation of the contacts from the paddle was noted on imaging. In both instances, paddle electrode damage appeared related to the proximity of the anchor.

Migration of Thoracic Spinal Cord Stimulator
