The use of surface electrography as a troubleshooting tool in deep brain stimulation

François Alesch MD; Hermann Lanmueller DI

Department of Neurosurgery (FA) - Center for Medical Physics and Biomedical Engineering (HL) - Medical University of Vienna, Austria

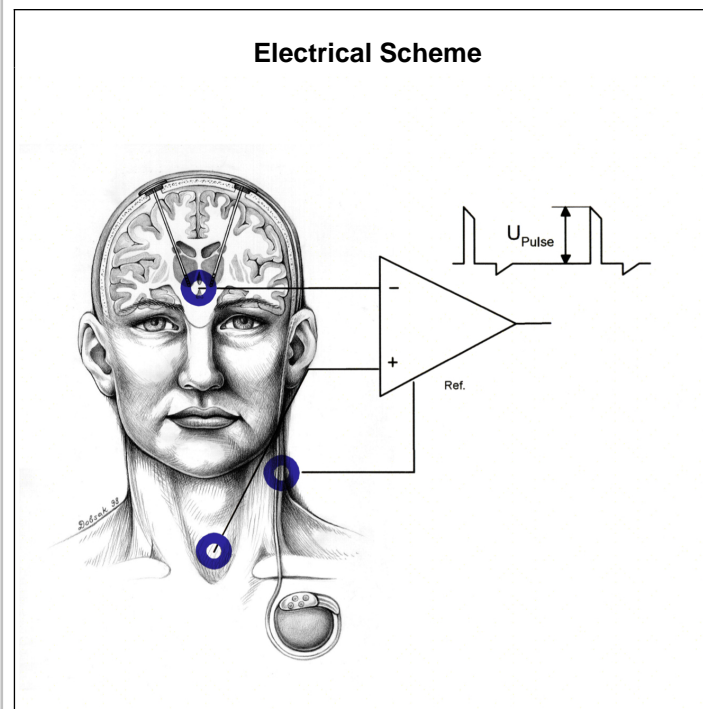
Failure

The present procedure was performed in a total of 60 patients with DBS systems where routine measurements of the impedance using the standard procedure (self test of the IPG) had either given ambiguous results or values suggesting a fracture of the lead extension. Only in six of these patients surface electrography corroborated these findings and consecutive replacement of the lead extension finally confirmed the presumed fracture. In another five patients the sudden loss of therapy was related to the IPG resulting in a change of the pulse curve. In all eleven patients efficient therapy resumed after surgical revision and they returned to normal surface electrography. We did not observe false positive results.
